2023 SRCLA Monitoring Summary

Bolfing, Cedar Island, Horseshoe, Krays, Knaus, Schneider

Sauk River Chain of Lakes Overview

Created January 2024

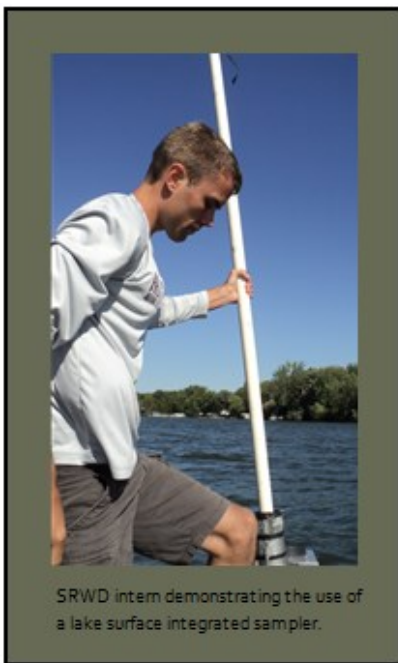
SRWD intern demonstrating the use of a lake surface integrated sampler.

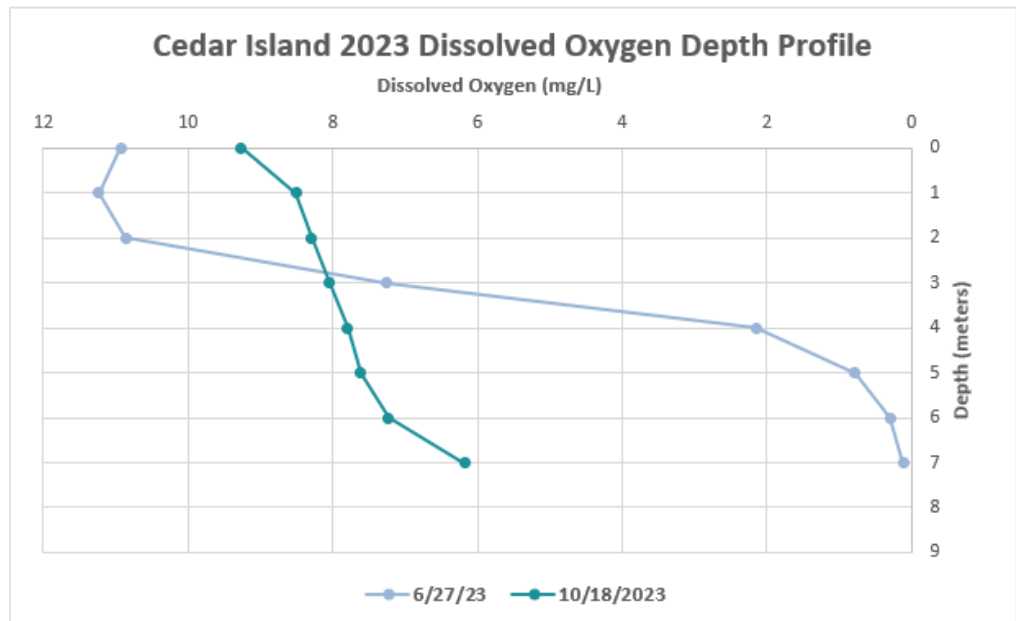
Cedar Island Depth Profiles - *Non-Flowage*

Cedar Island is one of the larger lakes in the chain, with 27 miles of shoreline and 76% of the lake being 15 feet deep or less. The temperature and dissolved oxygen profiles compiled here are both from sampling dates on June 27th and October 18th, 2023. The temperature and dissolved oxygen meter did not arrive until mid-June, so May 2023 depth data was not captured.

The temperature graph above shows that in June, the water temperature went from ~78°F near the surface down to ~52°F near the bottom. The oxygen concentrations graph below for Cedar Island shows a big reduction in oxygen levels around 2-4 meters depth on June 27th, with anoxic conditions near the lake bottom. This temperature and oxygen stratification was seen in the depth profile until mid-October. The depth temperature readings on October 18th vary only slightly throughout the profile, and the oxygen concentration near the bottom on October 18th was up to around 6 mg/L. This indicates that Cedar Island stratified by temperature and became oxygen-depleted in the early summer months. As temperatures cooled in the fall, the surface waters cooled, becoming more dense, and Cedar Island’s water column turned over and mixed. This occurred some time between 9/28 and 10/18.

In the future, it may be beneficial to deviate from the MPCA recommendation of taking samples from only May to September and take lake samples in October to assess nutrient loading after lake turnover. Turnover varies from year to year, but has been occurring later as time goes on.

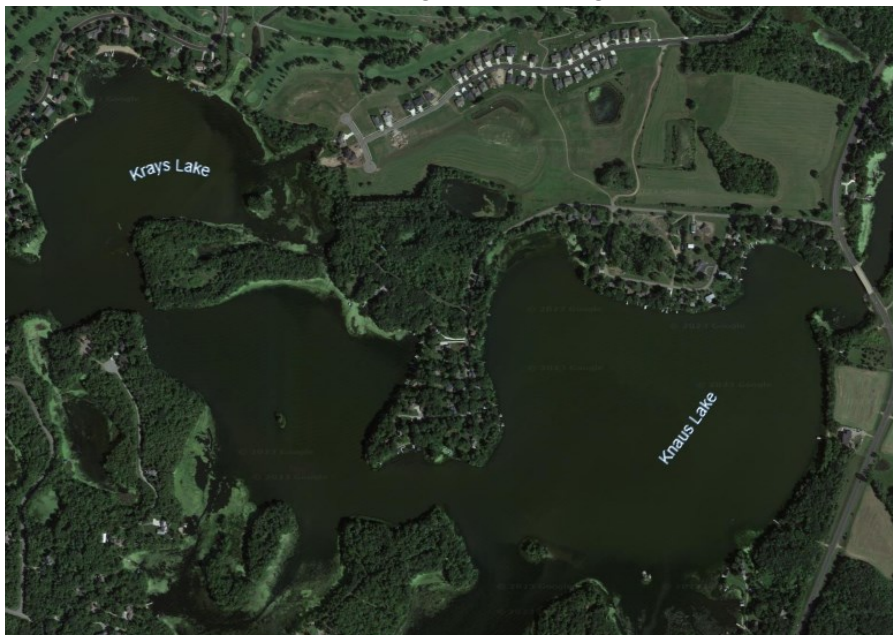
Krays and Knaus Lake Depth Profiles—Flowage

Krays and Knaus Lakes are Sauk River flowage lakes, and they have their own site-specific standards due to this unique flow condition. These lakes are very shallow, with the water quality sampling locations averaging just 7 feet. These shallow conditions do not allow for the lakes to stratify, and water temperature and dissolved oxygen concentrations are comparable throughout the profile. The graph above contains the surface water temperatures (graphed lines with axis labels on the left side of the graph) and dissolved oxygen concentrations (graphed bars with the axis labels on the right side of the graph) for both Krays and Knaus Lakes in 2023. Both lakes' temperature and oxygen concentrations were essentially equivalent throughout the season. The shallow nature of these lakes, along with a quick water residency time of just 7 days as the Sauk River flows through, keep the lakes well mixed and oxygenated throughout the season.

lowest average TSI for both lakes going back to 2009. Both Krays and Knaus Lakes are generally shallow, with an average depth of ~7 feet. The water in both lakes was approximately the same temperature and oxygen concentration throughout the year, and the water was well mixed from the top to the bottom of the water column. This indicates that Krays and Knaus Lakes generally do not stratify and do not contribute much internal loading of nutrients, as they do not experience hypoxic conditions.

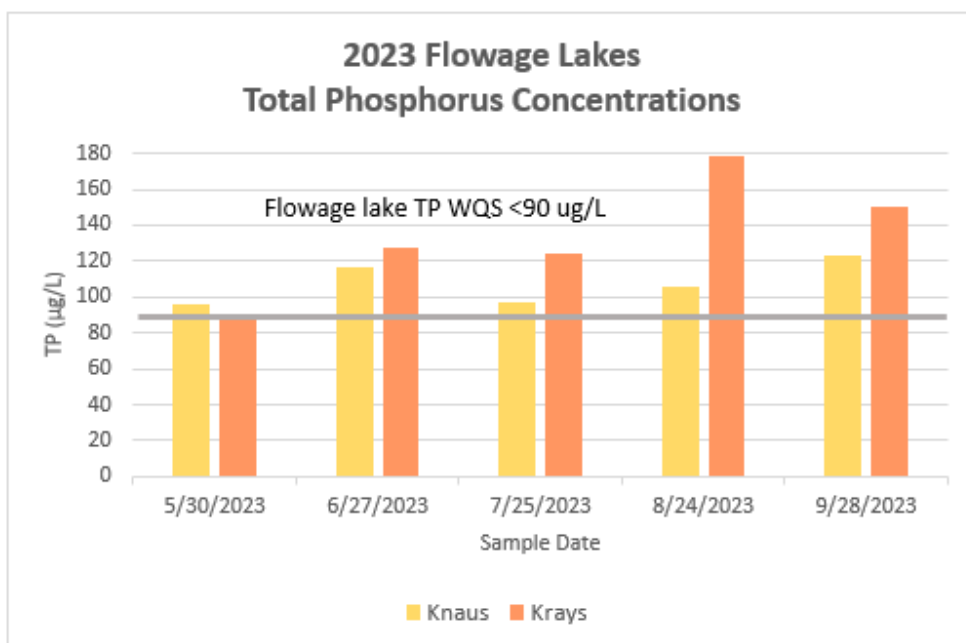
2023 Flowage Lakes WQ - *Kraus, Knaus*

Water quality standards for the flowage lakes in the Sauk River Chain of lakes are closer to the water quality standards for the Sauk River. This is because the quality of the water that passes through these lakes is greatly influenced by the existing water quality in the Sauk River. All chlorophyll-A samples from Knaus and Kraus Lakes in 2023 were below the water quality standard of 45 µg/L. All total phosphorus samples taken in 2023 exceeded the water quality standard of 90 µg/L for both lakes. It appears that Knaus Lake’s total phosphorus levels are consistently below levels in Kraus. This is likely due to Knaus Lake being further along the flowage lakes, giving nutrients more time to settle out or be metabolized by aquatic organisms.

All Secchi disk depth measurements were greater than the site-specific water quality standard of at least 2.6 feet for flowage lakes.

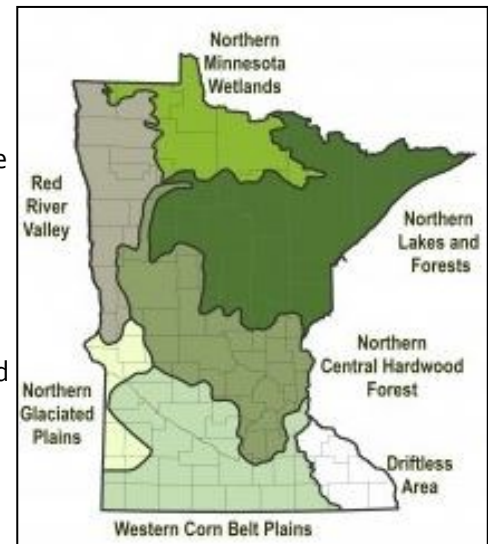
Ecoregion - A region defined by distinctive geography, plant and animal communities, land uses, soil profiles, and sun and moisture patterns. Ecoregions are used by the Environmental Protection Agency (EPA) and Minnesota Pollution Control Agency (MPCA) to characterize regional differences in the state and their effects on water quality. The Minnesota ecoregion the Sauk River watershed resides in is the North Central Hardwood Forest (NCHF). The NCHF ecoregion is a transitional zone between the predominantly forested northern lakes region and the corn belt plains in Southern Minnesota. In addition to the ecoregion classification, lakes are further classified as shallow or deep, depending on the maximum and average lake depths. The size and depth of a lake influences characteristics such as water clarity, water temperature, and aquatic plant growth.

River Nutrient Region - The EPA and MPCA did not develop nationwide or even statewide water quality criteria for surface waters, but instead developed guidelines for each unique ecoregion. Each ecoregion has been studied to identify reference conditions for that area. Reference conditions are used to reflect what a pristine or minimally impacted stream condition would be, and what the normal range of conditions are in that ecosystem. The MPCA has further researched and developed river nutrient criteria for each of Minnesota's ecoregions. This is the basis for creating water quality standards appropriate to each ecoregion's background conditions. See page 2 for the specific standards for our parameters of interest.
