**FLOWERING RUSH
NEW INFESTATION AND INNOVATIVE CONTROL PROJECT
2022-2023**

Sauk River Flowering Rush New Infestation and Innovative Control Project
Prepared For Stearns County COLA
2022-2023

Report Date: November 8, 2023

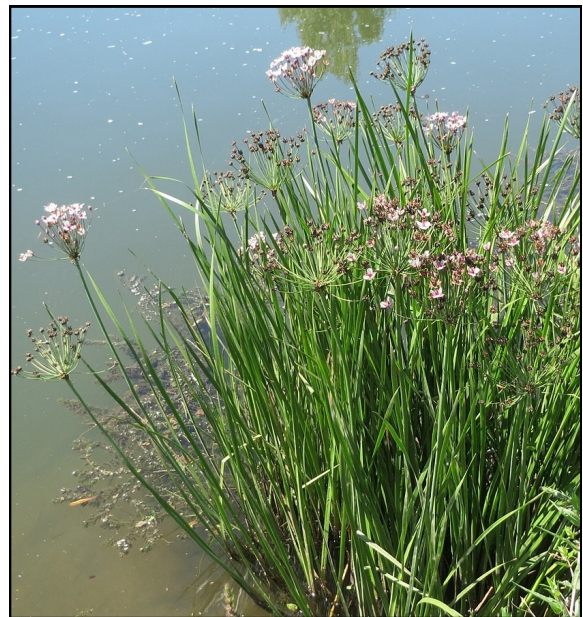
Fig. 1. Example of flowering rush in flowering stage.

The Stearns County COLA was awarded a MN DNR New Infestation and Innovative Control Grant in 2022 for management of flowering rush in a reach of the Sauk River extending south from Sauk Centre from where the river outflows Sauk Lake to an area south of Melrose where the river crosses Riverview Road south of I-95. This report details the outcome of the project (Fig. 1).

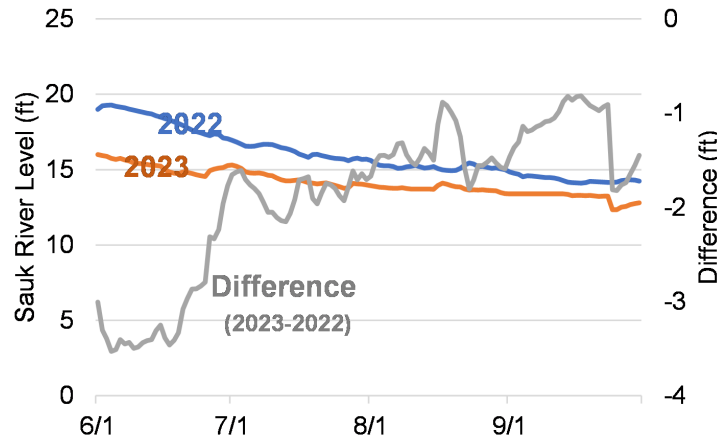
Fig. 5. Gauged water levels on Sauk River near St. Martin, MN at CR 12 for 2022 and 2023

Flowering rush, and most other plant species encountered in 2022 were overall reduced in 2023. There could be several reasons for this, but certainly one reason is that water levels were much lower in 2023 than in 2022 (Fig. 5). In fact, in a number of cases, points revisited in 2023 from 2022 were completely dry and on land. Certainly the timing may have also impacted findings, although many sources indicate that flowering rush is still metabolically active and should be observable well into October.
