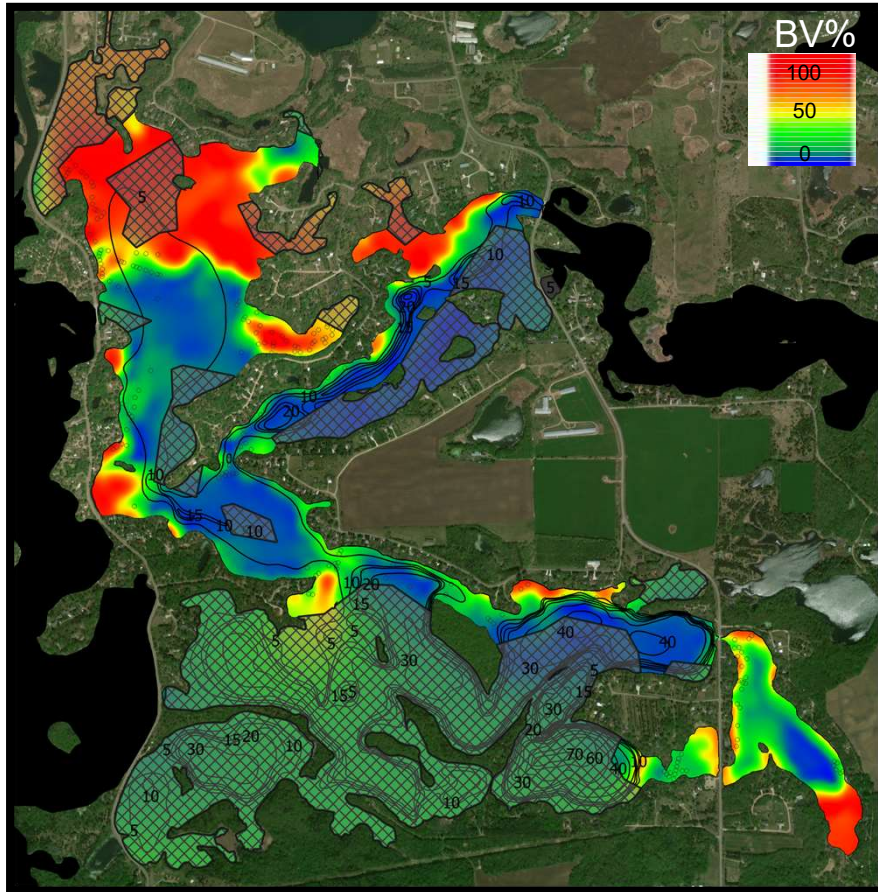
Plant biovolume by sonar and Biobase SAAS. Plant biovolume is the percentage of aquatic plants occupying the water column at a given point. Values of 0 (Blue) indicate no plants and 1 (Red) indicate plants at the surface of the water. Plant volume is not species specific (i.e., it includes more than curlyleaf pondweed). Hatched areas show where sonar data were too poor to generate an estimate or where surveys did not occur.

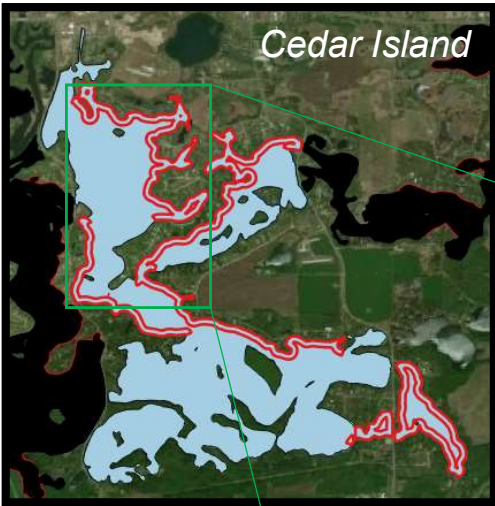
*Cedar Island Lake (73015700) delineated treatment area is 129.4 of 755 littoral acres (17%). Select a maximum of 113 acres (i.e., 15% of littoral zone) for proposed treatment total among all pages for this lake.*

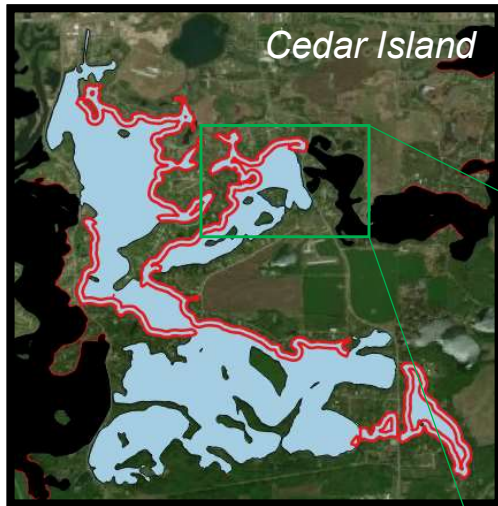
*Cedar Island Lake (73015700) delineated treatment area is 129.4 of 755 littoral acres (17%). Select a maximum of 113 acres (i.e., 15% of littoral zone) for proposed treatment total among all pages for this lake.*

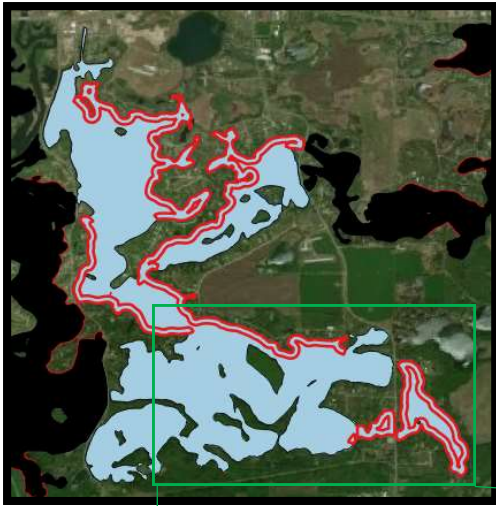
*Cedar Island Lake (73015700) delineated treatment area is 129.4 of 755 littoral acres (17%). Select a maximum of 113 acres (i.e., 15% of littoral zone) for proposed treatment total among all pages for this lake.*
